Document Number: XXXXXXXXXX

XXXXX 2, 2021

This letter summarizes the results of the structural assessment of a house located at [REDACTED], [REDACTED], GA XXXXX, inspected on XXXXX 30, 2021. The main purpose of this report is to verify if various types of cracks in the house are structural or cosmetics, etc. Inspected items are as follows:

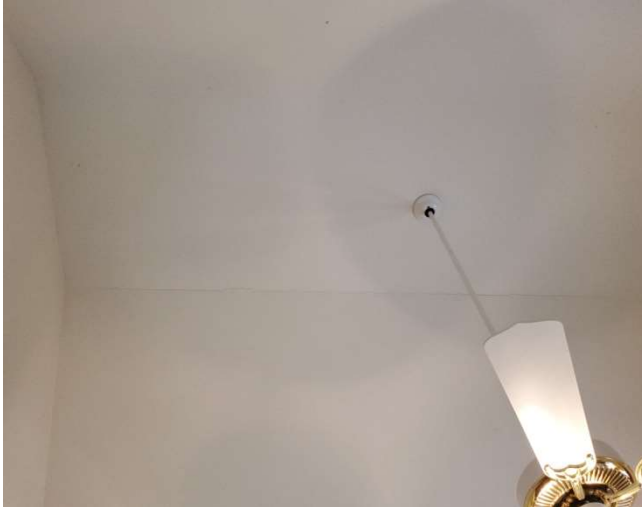
(a) Ceiling edge

In 1st floor, many cracks were observed at wall corner and ceiling-wall edges with similar pattern as shown in Fig. 1. Most crack widths were no larger than 1/16". Thus, they were identified as cosmetic cracks, not structural, due to temperature and moisture expansion & contraction or movement for gypsum board products. The moulding sealants at the edge of the ceiling were also observed to have gaps for similar reasons. They can be fixed by crack sealant or filler as required.

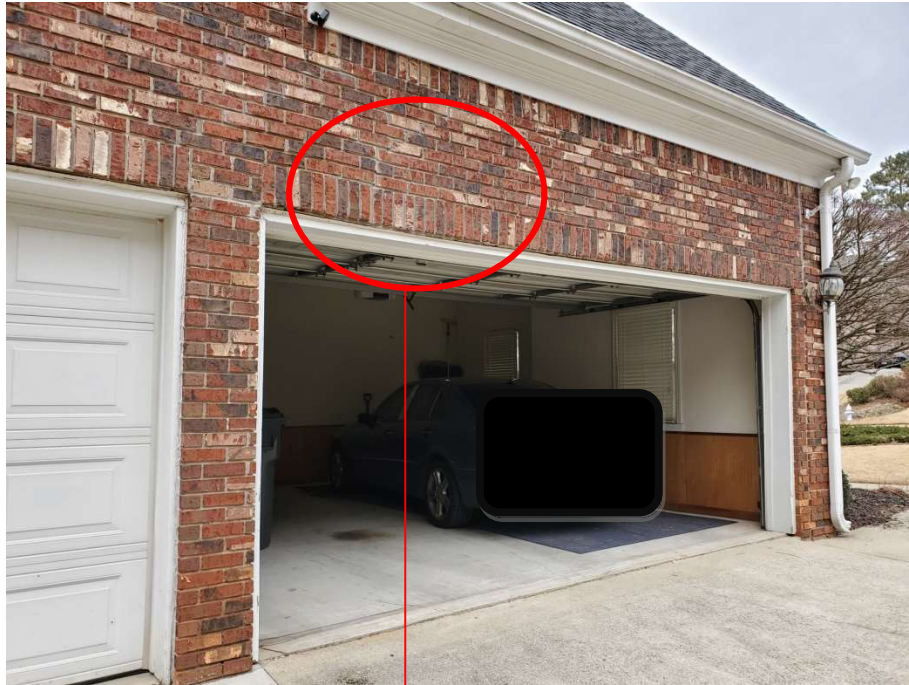
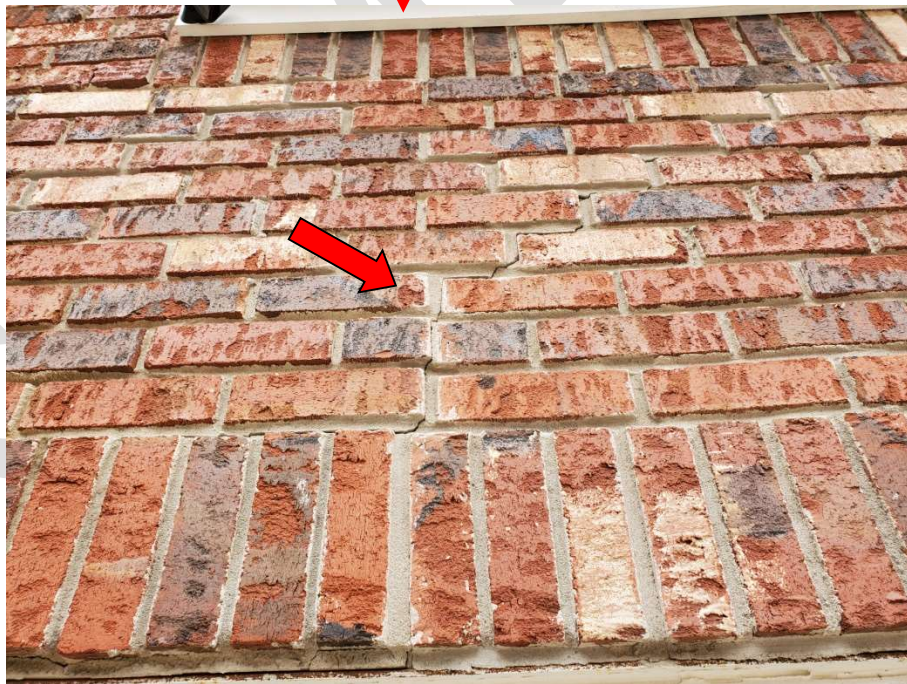
< Fig. 2 – Step cracks at brick veneer >

Step cracks were observed following mortar joints of the brick veneer wall as shown in Fig. 2 is wall. It is located at the outside garage door above. Door opening size is approximately 16'-0" wide x 7'-0" high. When measuring the opening height at both ends and midpoint, it was observed that a deflection of about 3/4" occurred in the mid span. From this, this crack may be caused by the deflection of the brick lintel. Also, there is a gap between the lintel and brick mortar. The current crack width is less than 1/16", so it doesn't need to repair right away. However, if the cracks get bigger in the future, it is recommended to discuss with a crack repair agent.

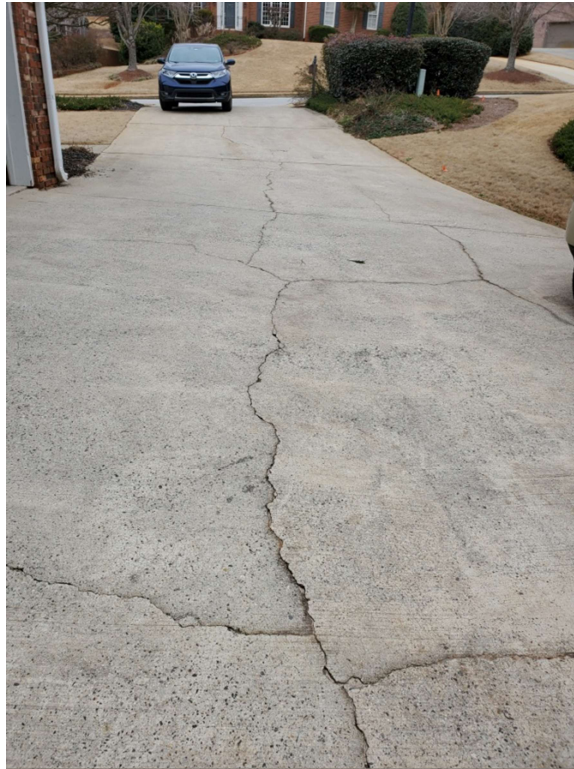
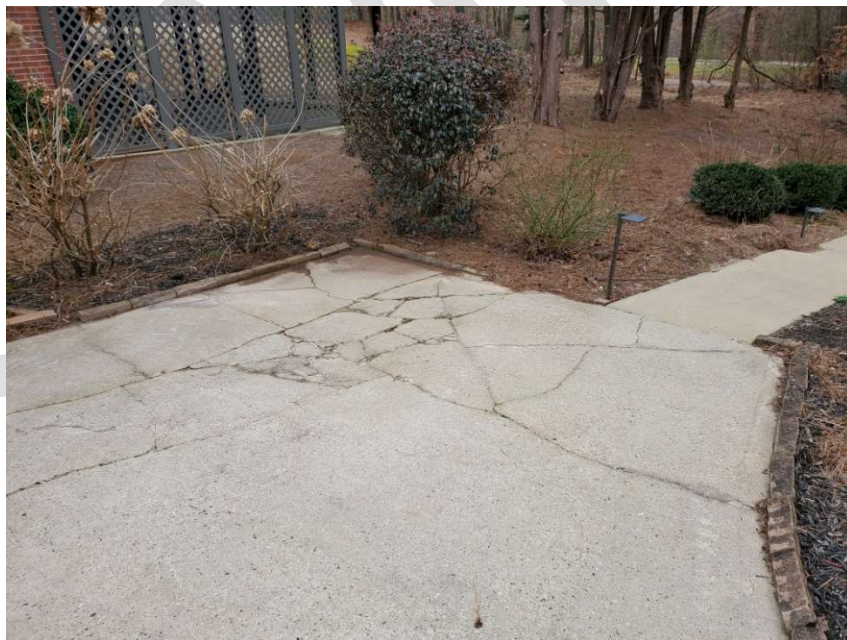
< Fig. 3 – Cracks at driveway >

In driveway, many irregular patterns of cracks were observed as shown in Fig. 3. They are common as a driveway ages and weather takes its toll. In the middle of the driveway, a longitudinal crack was observed, which is believed to have occurred because of the absence of control joint in this direction when pouring concrete. These cracks can be fixed by concrete crack fillers or if getting worse, they may have to be replaced.

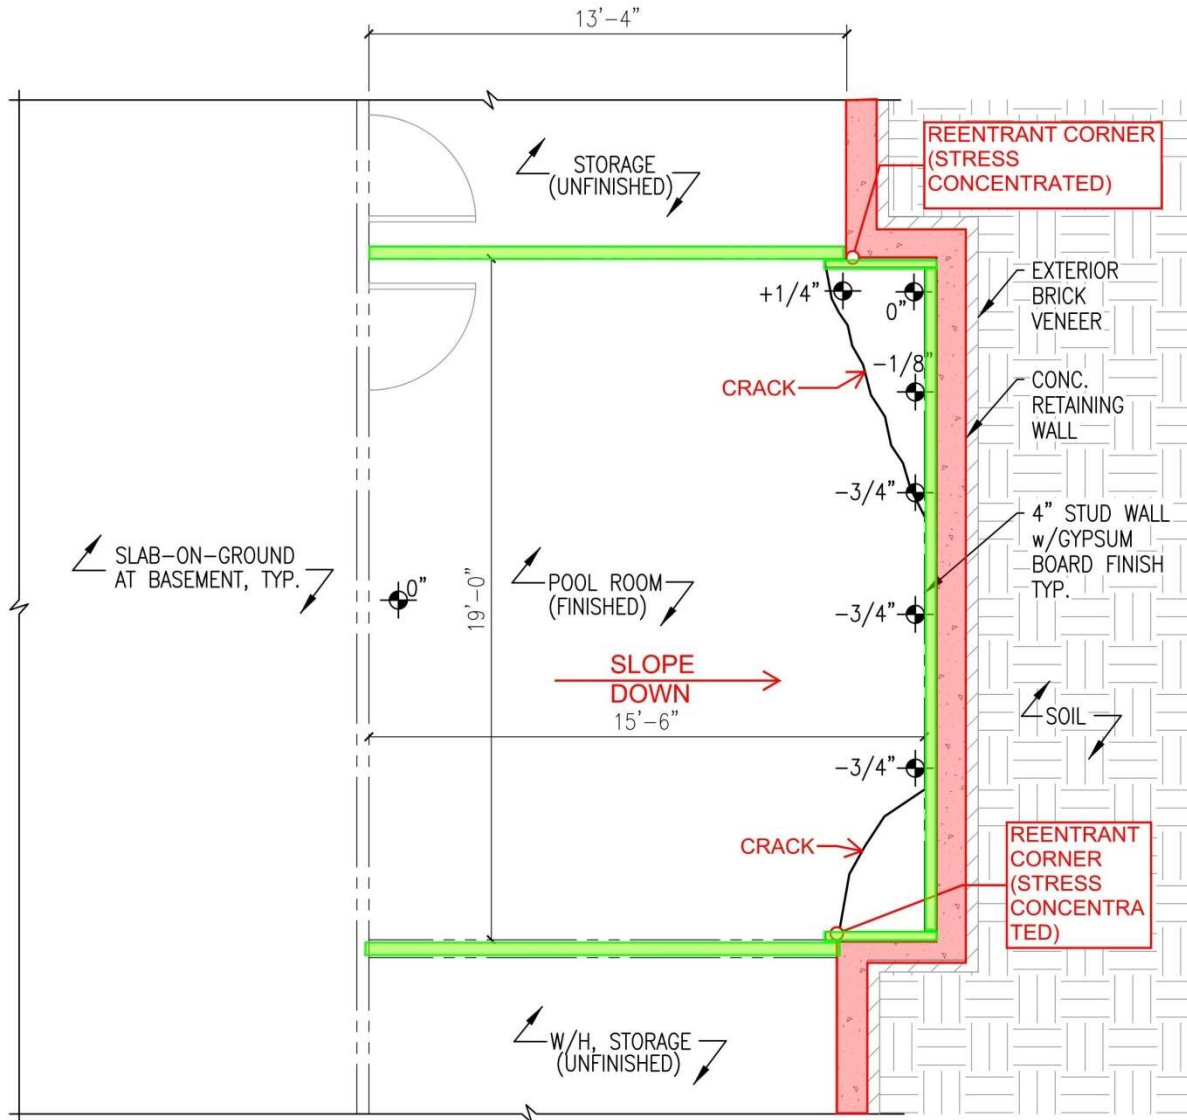
< Fig. 4 – Partial plan at basement pool room >

Basement floor is a concrete slab-on-ground without crawl space surrounded by concrete retaining walls at 3 sides. No cracks were observed at the retaining wall. However, as shown in Figs. 4 to 6, about 1/8"

wide cracks were observed at pool room. These cracks started at both the re-entrant corners and propagated to the middle of the wall. Level measurements were conducted to determine the elevation differences. As shown in Fig. 4, this room has a downward slope from the entrance of the room to the opposite wall, and the level of the cracked area was slightly higher than that of the non-cracked area. But the differences are not too much. No cracks were found in the outside brick veneer at the same location of this room (see Fig. 8). Thus, it is believed that these cracks were caused by stress concentration at the wall reentrant corner due to temperature shrinkage & expansion as well as slight wall movement rather than by the settlement of the foundation. In general, rebar is required at the face of a re-entrant corner in concrete slab to prevent them. To prevent the cracks from getting bigger, it is recommended to repair them by concrete repair contractor.
