Document Number: XXXXXXXXXX

XXXXX 2, 2021

This letter summarizes the results of the structural assessment of a house located at [REDACTED], [REDACTED], GA XXXXX, inspected on XXXXX 30, 2021. The main purpose of this report is to verify if various types of cracks in the house are structural or cosmetics, etc. Inspected items are as follows:

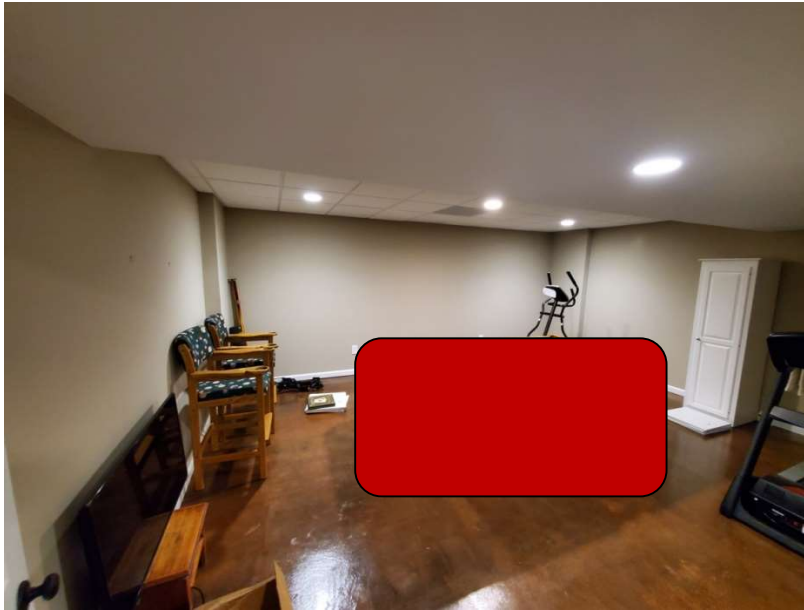
< Fig. 7 – Overall view of pool room >

wide cracks were observed at pool room. These cracks started at both the re-entrant corners and propagated to the middle of the wall. Level measurements were conducted to determine the elevation differences. As shown in Fig. 4, this room has a downward slope from the entrance of the room to the opposite wall, and the level of the cracked area was slightly higher than that of the non-cracked area. But the differences are not too much. No cracks were found in the outside brick veneer at the same location of this room (see Fig. 8). Thus, it is believed that these cracks were caused by stress concentration at the wall reentrant corner due to temperature shrinkage & expansion as well as slight wall movement rather than by the settlement of the foundation. In general, rebar is required at the face of a re-entrant corner in concrete slab to prevent them. To prevent the cracks from getting bigger, it is recommended to repair them by concrete repair contractor.
